UNITED STATES ENVIRONMENTAL PROTECTION AGENCY
REGION I - EPA NEW ENGLAND

SUBJ: Recon of storm water outfalls around Coes Reservoir, Worcester MA.

FROM: Douglas Koopman, Environmental Engineer
Water Technical unit

Date of inspection: 7/15/11

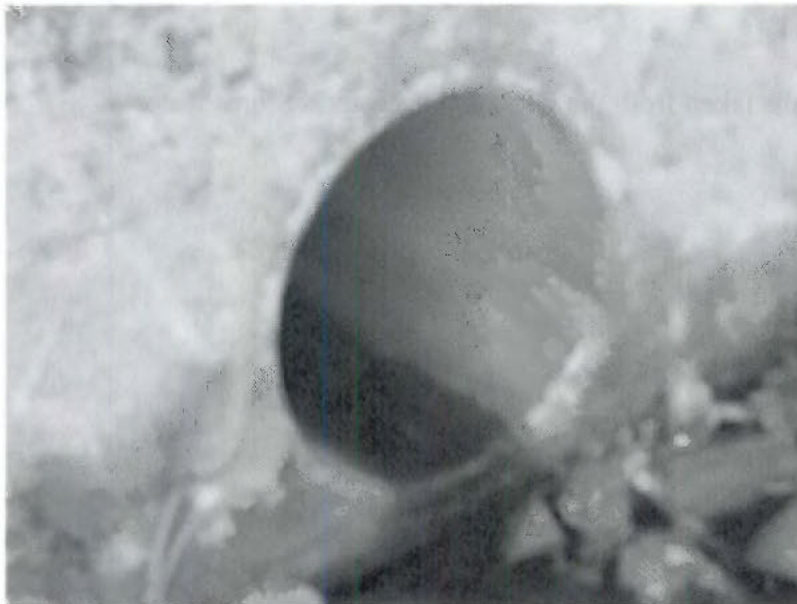
159 Mill Street

One outfall was flowing very slowly. The Inspector took picture and sample to run the field kit tests. The following results were obtained: NH_3^- .25ppm, CL^- .08 ppm, Surfactants - <.25ppm.

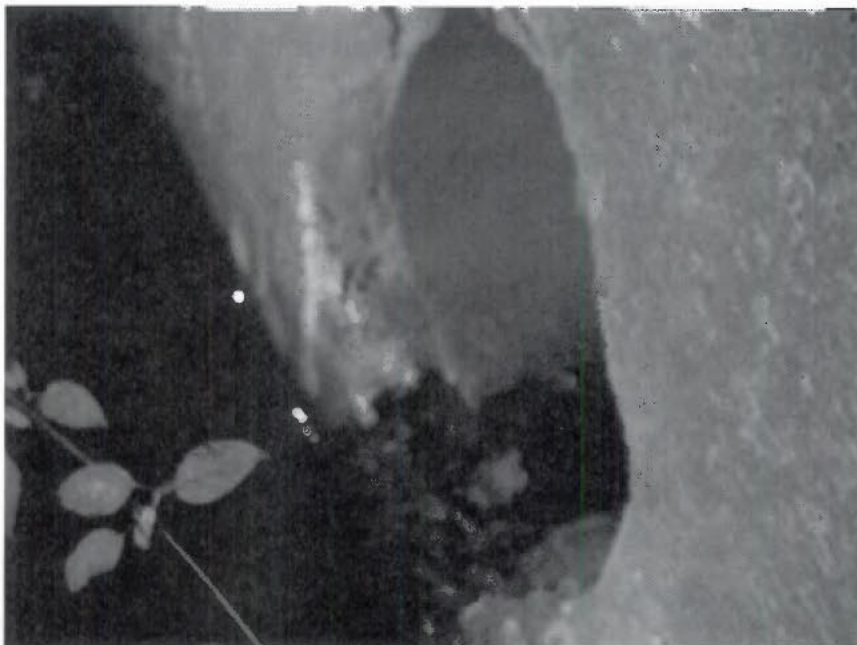
225 Mill Street

One outfall was located at this location. Outfall had a small amount of flow coming from the pipe. The inspectors could not collect a sample directly from the pipe so a sample of water was taken below the discharge in order to run the field kits. The following results were obtained: NH_3 - .0 ppm, CL^- - .14 ppm, Surfactants - <.25ppm.

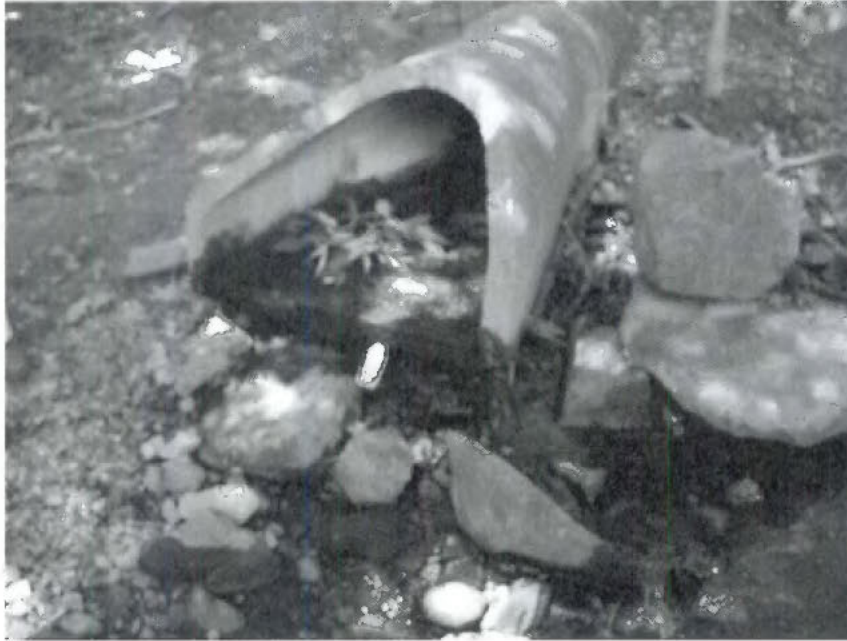
93 Outlook Drive: The inspectors found 2 outfalls at this location. The list from the storm water report shows 3 outfalls at this location. One of the outfalls identified had water flowing from it and a sample was taken to run the field kit. The following results were obtained: NH_3 - 0 ppm, CL^- - .11 ppm, Surfactants - 0 ppm.

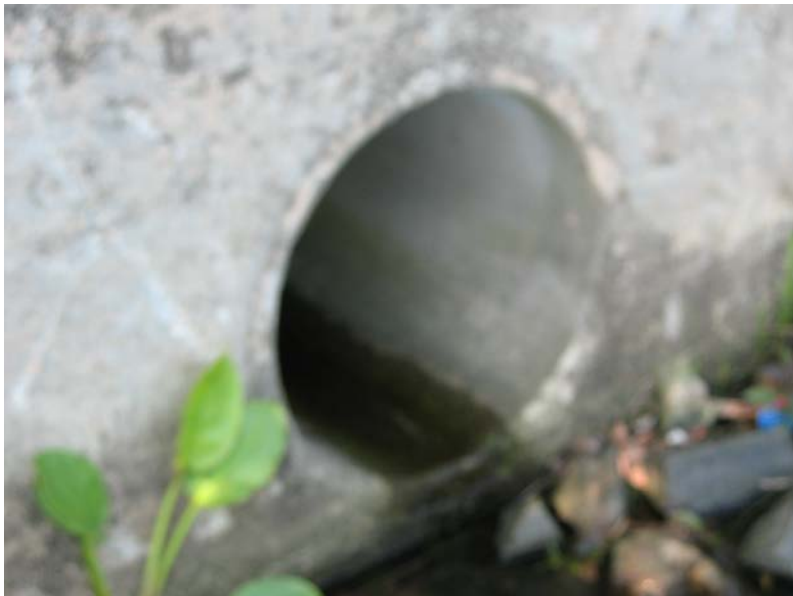
159 Mill Street

One outfall was flowing very slowly. The Inspector took picture and sample to run the field kit tests. The following results were obtained: NH_3^- .25ppm, CL^- .08 ppm, Surfactants - <.25ppm.

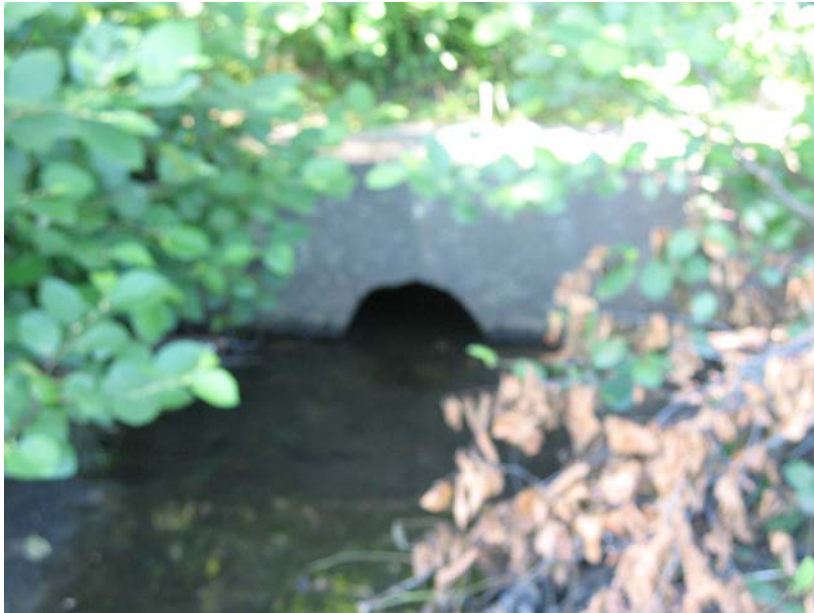
The second outfall located at 159 Mill Street. Water was up into the pipe so no sample was taken.

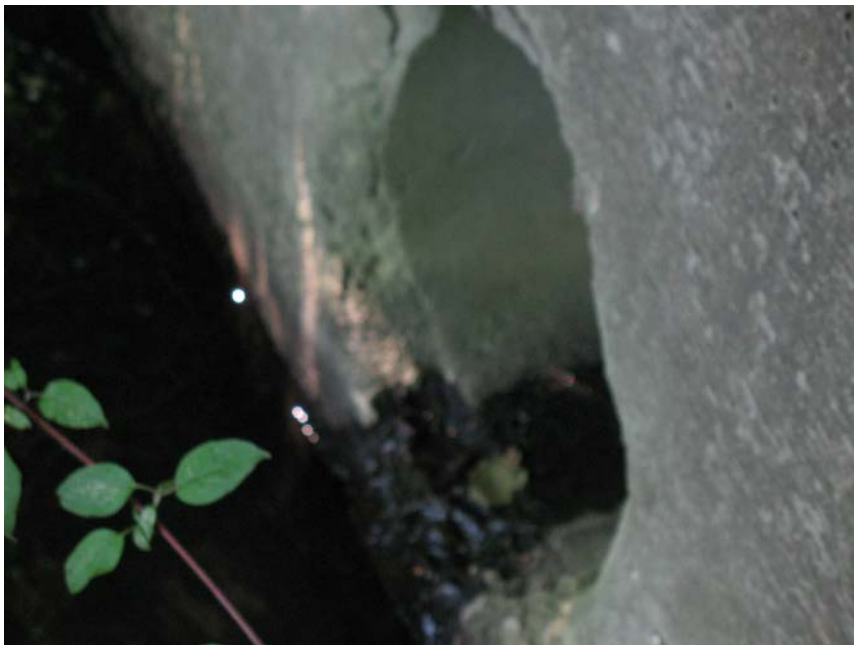
225 Mill Street

One outfall was located at this location. Outfall had a small amount of flow coming from the pipe. The inspectors could not collect a sample directly from the pipe so a sample of water was taken below the discharge in order to run the field kits. The following results were obtained: NH_3 - .0 ppm, CL^- - .14 ppm, Surfactants - <.25ppm.

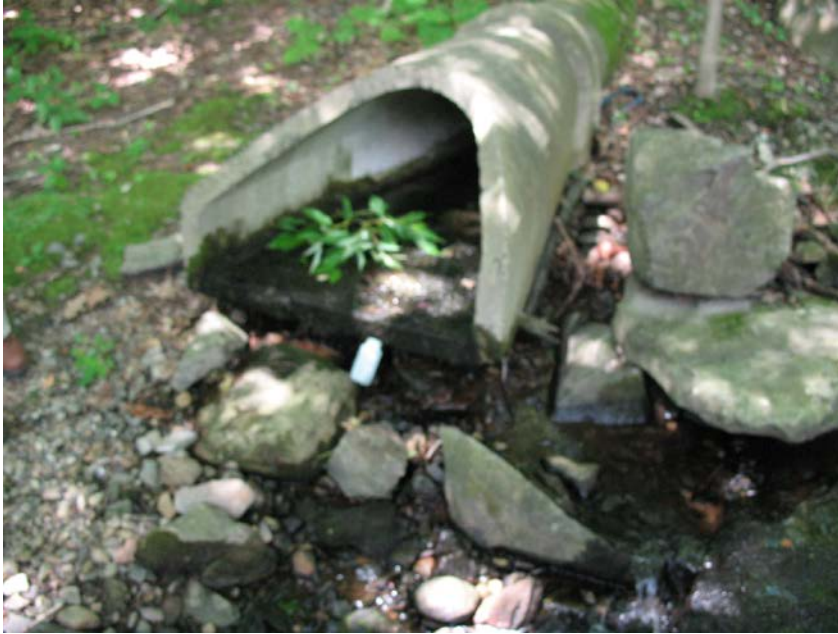
93 Outlook Drive: The inspectors found 2 outfalls at this location. The list from the storm water report shows 3 outfalls at this location. One of the outfalls identified had water flowing from it and a sample was taken to run the field kit. The following results were obtained: NH_3 - 0 ppm, CL^- - .11 ppm, Surfactants - 0 ppm.
